# FORUM ACUSTICUM EURONOISE 2025

## BUILDING ENVELOPE ASSESSMENT OF AIRTIGHTNESS USING AN ACOUSTIC CAMERA: A CASE STUDY IN VALLADOLID, SPAIN

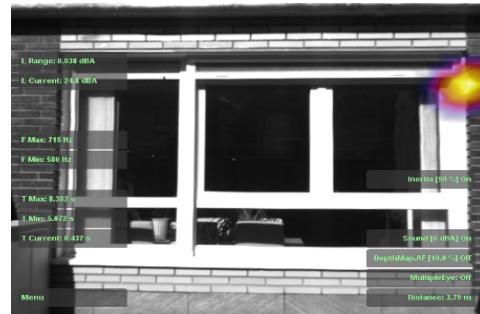
Fig.6 and Fig.7 show persistent SPL peaks in the same position (upper right section of the terrace window frame), in different moments and under blower door pressurization 50 Pa conditions. This position is also seen when performing the smoke generator test integrated with blower door as shown in Fig.8. These SPL peaks points were found across multiple frequency bands and are shown for the following intervals: 580–715 Hz and 1647–1829 Hz. Due to its position on the edge of the window frame, these spots are preliminary identified as potential air leakage spots.

**Figure 6.** SPL peak located in upper right window frame in House 1. (50 Pa pressurization. AC outside)

The SPL peaks shown in Fig.6 and Fig.7 (upper right corner of the window façade) is located on the edge of the frame and aligns with the smoke generator results, strongly supporting the conclusion that, at this location, there is an air leakage path.

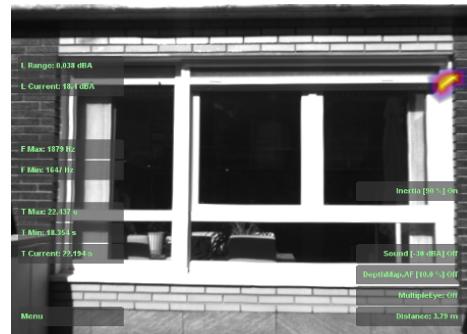
**Figure 7.** SPL peak located in in upper right window in House 1 (50 Pa pressurization. AC outside)

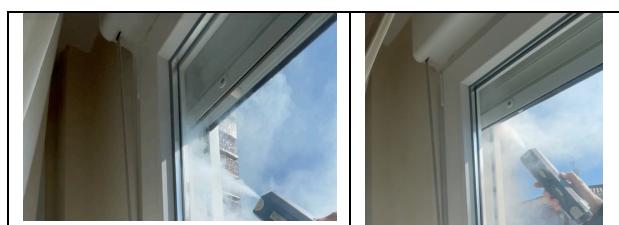
**Figure 8.** Visual identification of air leakage locations in House 1 using smoke generator

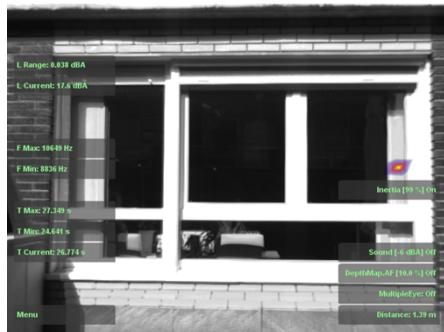
On the other hand, when using the sound source as an excitation signal, a sound peak is detected close to the previous location across the frequency band of 1016–1211 Hz as shown in Fig.9. Due to its position slightly away from the frame edge and directly on the window (curtains behind the sound peak shown in figure 10), it is not considered a potential air leakage spot but rather an external sound reflection or glass vibration.

**Figure 9.** SPL peak located on the glass (curtain behind), close to the right side of the window frame in House 1. (Sound source inside. AC outside.)

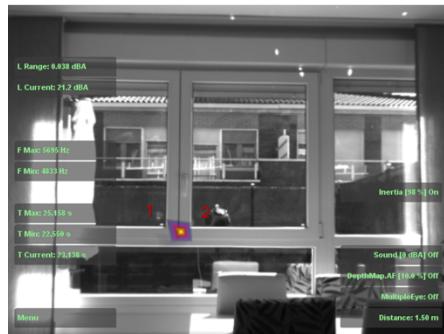
When the tests were performed with the blower door under depressurization conditions (50 Pa and 80 Pa) and the acoustic camera was placed inside the house, SPL peaks were detected exactly between window frames 1 and 2, as shown in Fig.10 and Fig.11, notably in higher frequency band: 4833–5695 Hz. Other sound peaks have been identified within different time periods and across different frequency bands as summarized in Tab.1. All these spots shown in Tab.1 are potential air leakage spots due to their position.

**Figure 10.** SPL peak located between adjacent window frames in House 1. (50 Pa depressurization. AC inside)

On the contrary, the SPL peak observed in Figure 10 is located over the glass. Since the glass was visually inspected and confirmed to be intact with no cracks or defects, this signal is likely the result of structure-borne sound or vibration rather than air leakage.

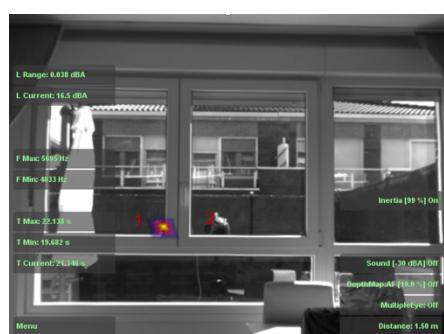
**Figure 11.** SPL peak located between adjacent window frames in House 1 (80 Pa depressurization. AC inside)

Lastly, another SPL peak zone was consistently identified under depressurization conditions, at a location which was not observed with the smoke generator. This is around the lower edge of the frame, near the junction of both frames. This SPL peak zone was detected very consistently at middle frequencies as shown in Tab.1, but it was more precisely spotted at higher frequencies as shown in Fig.10 and Fig.11. According to its position, it is very likely an air leak path. If we assume this is a crack or infiltration path, it is likely very narrow—possibly too thin to be detected by the smoke method and better detected at higher frequencies. This suggests that the acoustic method is particularly sensitive to small or layered cracks that may not be visible using smoke or fog-based techniques. Lower frequency bands (as shown in Tab.1) also detected the signal, but with less accurate localization.

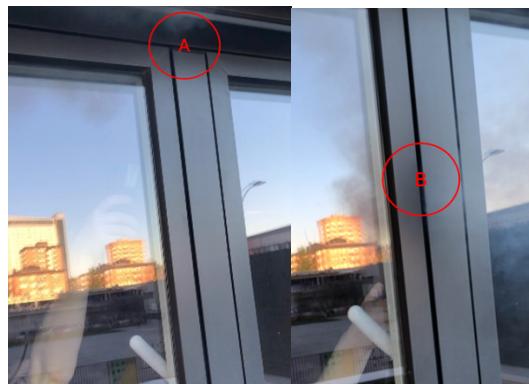
The evaluation of House No. 2 focused on verifying and analyzing air leakage detected visually via smoke generator. Fig.12 shows two key locations where fog was observed to come out when the fog generator was used inside the house. Fig.13 identifies the upper frame area as position A and the lower frame zone between adjacent window segments as position B. In fact, position B corresponds to the position of a small open/close micro-ventilation opening.

**Figure 12.** Visual identification of air leakage locations in House 2 using smoke detection

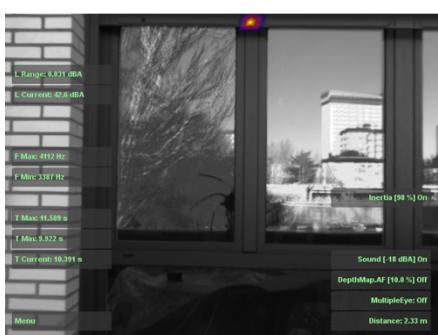
When the sound source is used as excitation signal, a SLP peak is also observed at the same location but at a higher frequency band of 3387 - 4112 Hz as shown in Fig.14.

**Figure 14.** SPL peak at Position A in House 2. (Sound source inside. AC outside.)
