ON THE IMPORTANCE OF ROOM ACOUSTIC TREATMENT OF HOSPITAL CORRIDORS – ACOUSTIC INTERVENTION IN HOSPITAL VALL D’HEBRON (BARCELONA)

Juan Negreira^{1*} Ivana Rossell² Mai-Britt Beldam³

¹ Saint-Gobain Ecophon Spain

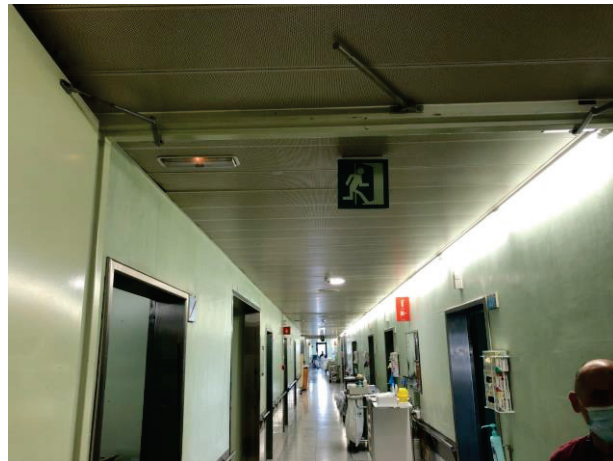
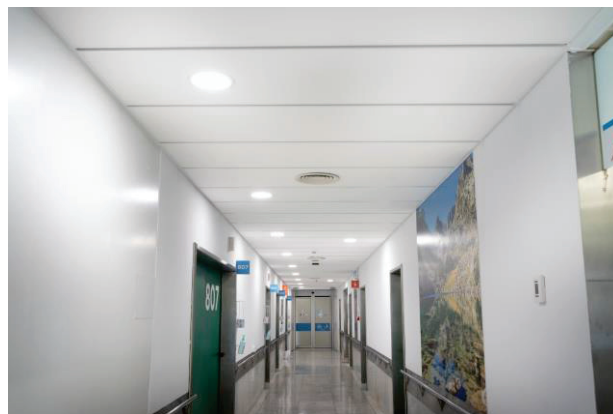
The initial state of the corridor is shown in Figure 3. The floor was made of ceramic tiles, whereas the walls were plasterboard on top of masonry. Wooden doors were installed along the corridor as entrance to the bedrooms, and at the end of the corridor a glass sliding door was installed. The existing ceiling before the renovation was a perforated metal ceiling, with an acoustic lining on top. The maintenance department was not able to provide information about it to the authors about the exact model of the ceiling, but a qualified guess would be that the ceiling was either Class B or C absorption.

A refurbishment was carried out in the corridors, and its final state is shown in Figure 3. The materials in walls and floor remain the same as before (just aesthetic change), however the ceiling is now different. The new system installed is an Ecophon Access (absorption class A – see Table 1 and Figure 2), allowing accessibility to the soffit.

Figure 3. Corridor before (upper picture) and after (bottom picture) renovation.

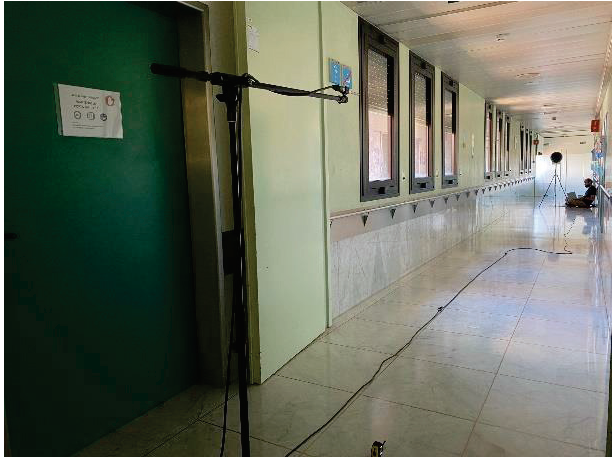
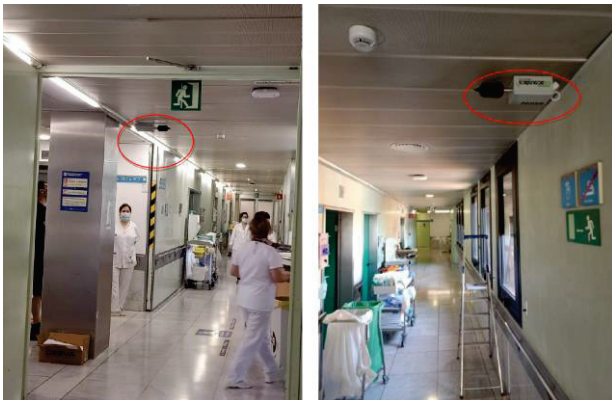
Acoustic measurements were performed aiming at assessing the acoustic quality of the corridor both before and after the intervention. More specifically, reverberation time and sound propagation measurements according to ISO 3382-2 and ISO 3382-3 respectively were carried out. Moreover, noise levels at two locations of the corridor were monitored, namely one at the intersection between both

Figure 4. Measurement set-up for sound propagation measurements following ISO 3382-3 (upper picture) and placement of the noise monitoring device at two different locations (bottom picture).

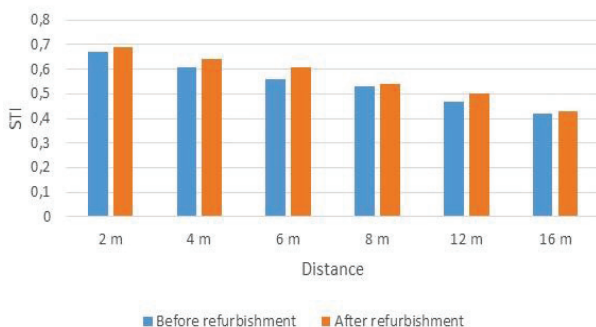
STI measurements at different locations from the source were carried out, the results being shown in Figure 6. A slight improvement (i.e. decrease in STI/intelligibility) is depicted, due to the attenuation of sound propagation the new ceiling has provided.

Figure 6. Comparison of the STI measured at different positions along the corridor both before and after the refurbishment, with the sound source located by the nursery station at S1 (cf. Figure 1).

Without obstacles, RT decreases with increasing STI. On the contrary, if the STI goes down (without hindrance), it means the RT has gone up. The latter is not optimal in cases where RT is not low enough; however in cases where RT is slightly higher like the one under study, it becomes a compromise between privacy (i.e. sound propagation) and noise levels. Noise barriers such as sliding glass doors (if possible) and wall panels could help lessening propagation.
