# FORUM ACUSTICUM EURONOISE 2025

## MITIGATING GROUND-BORNE VIBRATIONS WITH A BOX-IN-BOX SOLUTION: FEASIBILITY AND CHALLENGES IN A REAL CASE STUDY

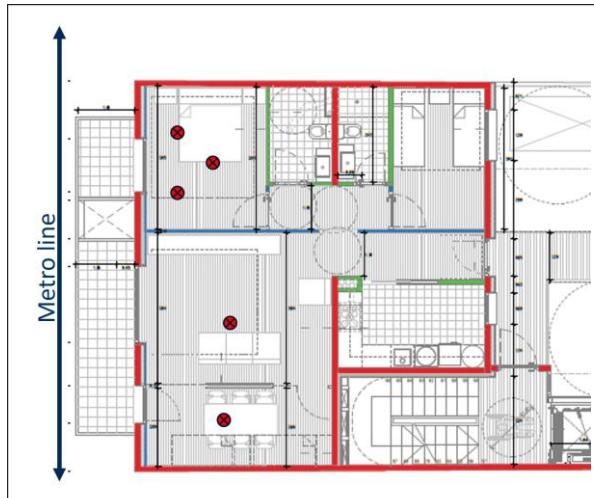
**Figure 5.** Measurement points in the apartment closest to the metro line.

stage, with finished walls, floors, doors, and windows, vibration measurements have been carried out at four control points: three in the bedroom and two in the living room of the apartment closest to the metro line. These measurements were taken on each of the three floors with residential units (PL2, PL3, and PL4, as shown in Fig. 5).

Measurement Point	Background $L_{aw}$ [dB]	Maximum $L_{aw}$ [dB]
PL2 Bedroom	44.6	71.1
PL3 Bedroom	49.2	76.3
PL4 Bedroom	51.7	71.1
PL2 Living Room	44.7	73.4

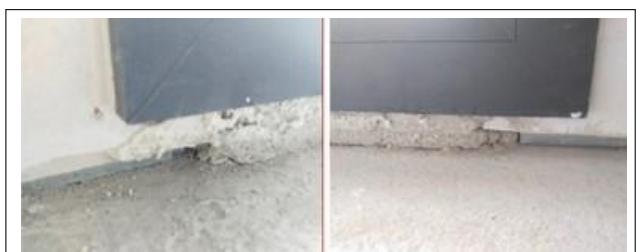
**Figure 7.** Acoustic bridges in critical room.

Following this assessment, a technical inspection of the building's structural elements was carried out to identify possible causes of the elevated vibration levels. The investigation revealed the presence of a mortar bridge beneath the balcony door frame, which was likely facilitating the transmission of vibrations from the structural floor (non-isolated part) to the bedroom floating floor (see Fig. 7). This rigid connection was suspected to be a significant contributing factor to the non-compliant vibration levels in the affected area.

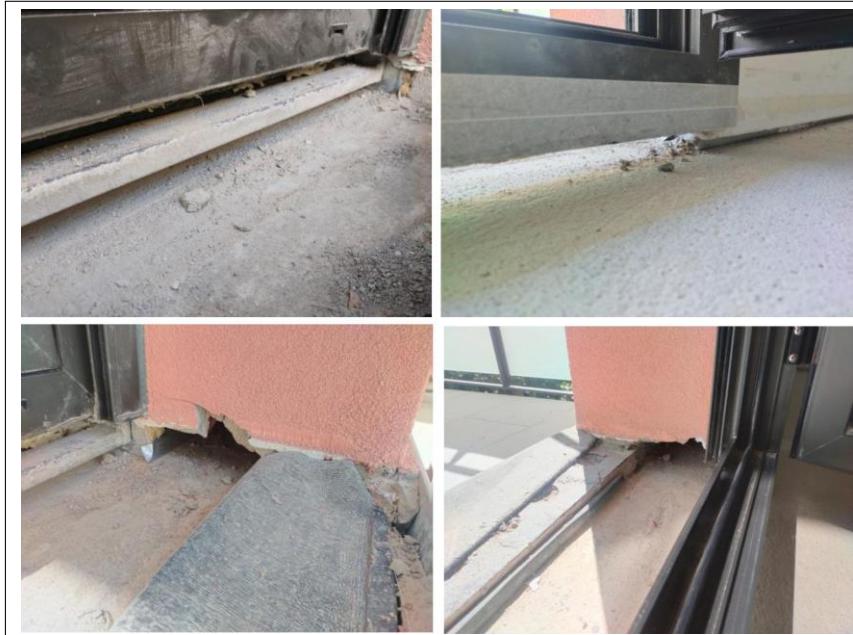
**Figure 8.** Removing the acoustic bridges before the final assessment.

To address the identified issue, a series of corrective measures were implemented to eliminate the acoustic bridges beneath the balcony door frame. These measures involved removing the rigid connections and ensuring that no direct pathways remained for vibration transmission. Special attention was given to the interface between the door frame and the floating floor to prevent any residual mechanical coupling that could compromise the effectiveness of the isolation.

Figure 8 provides a detailed illustration of the corrective measures undertaken. Following the modifications, a repeat measurement campaign was conducted at the same four positions within the affected bedroom to verify the effectiveness of the intervention. The updated results, presented in Tab. 5, confirm that vibration levels at all measurement points now fall below the legal limit of 75 dB, ensuring compliance with current regulations.
