AN ARCHAEOACOUSTIC ANALYSIS OF THE LATE MEDIEVAL ST. MARY'S CHURCH OF SASTAMALA

Pyry-Herkko Sadeaho^{1*} Mikko Kylliäinen¹ Jesse Lietzén¹
¹ AINS Group, Department of Acoustical Engineering, Finland

This paper describes the historical changes in acoustics of the late medieval St. Mary's church of Sastamala located in western Finland. The church has been the main venue of an annual early music festival since 1996, and its acoustics have garnered attention also internationally. From the 1500s to date, the church has gone through several renovations. This study aimed to determine how the current acoustic conditions have been shaped. This was achieved by modelling the church and its acoustics at different points in time. The room acoustic model of the present-day church was validated with in-situ measurements. The validated model was then altered to account for the state of the church in 1777 and 1870. Information necessary for modelling the historical states of the church was acquired from literature, archives, and interviews. According to the simulations, the reverberation time has become shorter in every major renovation. The changes to the interior have affected other room acousti

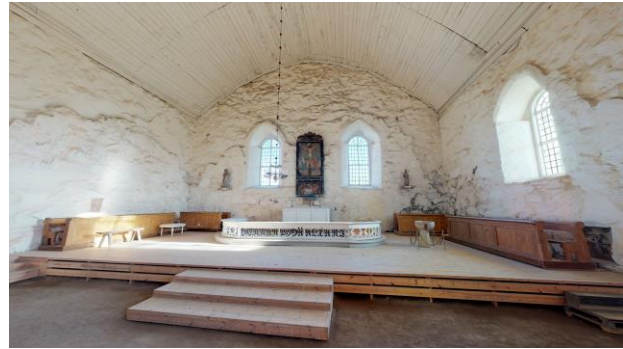
Figure 1. The St. Mary's church of Sastamala in its current state. The view to the chancel.

The church was originally intended to be a twin-aisled with four bays. This can be seen from still existing vaulting supports and concluded from the configuration of the two windows of the chancel (see Fig. 1 and 2). However, the intended masonry vault structure was never implemented, which was, in fact, not very exceptional. In Finland, then part of the Swedish kingdom, masonry vaults in several late medieval churches were never built because of the transition from Catholicism to Lutheranism due to the Reformation. [1] There is no reference to a ceiling structure

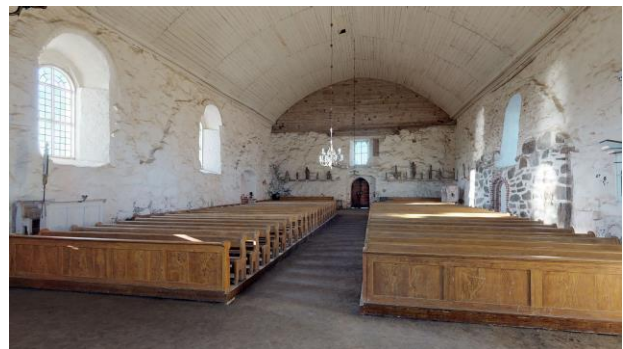
Figure 2. The St. Mary's church of Sastamala in its current state. The view from the chancel to the nave.

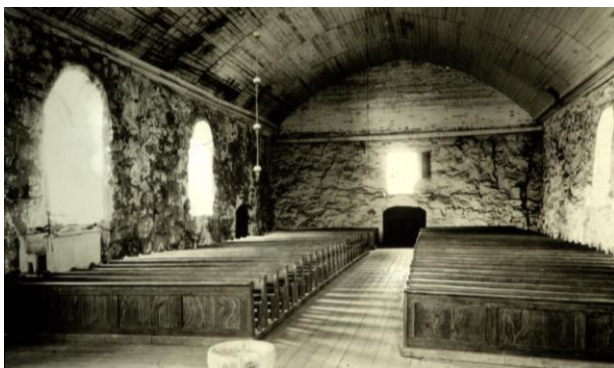
Figure 3. The nave of the church before the renovation carried out in 1960–1962. (The Aalto University archives)

In 1913, the new church of the parish was completed, and the St. Mary's church was abandoned. As unused, the church started to come apart once again. In the 1950s, several inspections concerning the condition of the church were conducted. Therefore, several propositions for actions were made to save the remaining structure and interior from coming apart. In 1959, the Regional Council of Pirkanmaa implemented the restoration of the church to its more original form. The renovation was then carried out between the years 1960–1962. At the time, the roof was restored to its original height, the wooden floor was lowered down 0,6 m, the interior walls were replastered and painted, and the pews were repaired. [5] The former interior is seen in Fig. 3 in which the surface of the floor was higher than it was after the renovation (see Fig. 4).

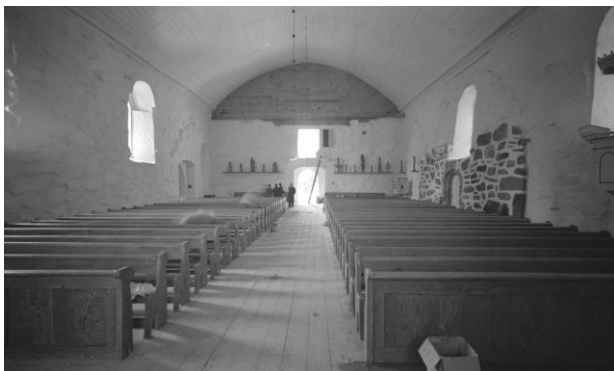
Figure 4. The nave of the church after the renovation was completed in 1962. (E. Lahtinen, Vapriikin kuva-arkisto, 1962)

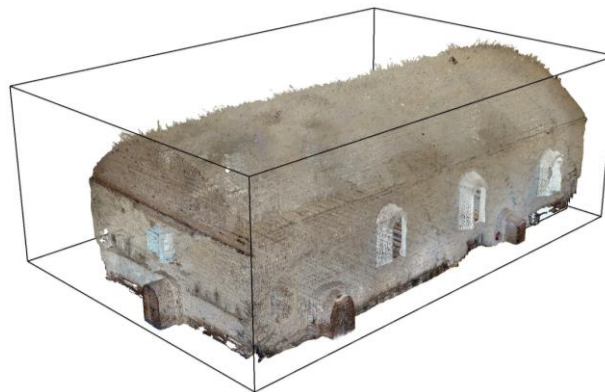
Figure 7. The point cloud of the present-day church.

The geometry of the church was discovered by producing a 3D model of the interior using an AI-powered 3D capturing system. The system was using SLAM³ technology based on RGB-D images which is a combination of RGB image and depth image. Briefly, the algorithm of the system then uses elements from the picture including RGB values and spatial data to align adjoining scans to reconstruct the geometry of

the space. Additionally, a point cloud⁴ was obtained from the captured data, which is presented in Fig. 7. To ensure the accuracy of the produced data, some in-situ verification measurements of the internal dimensions were also made.
