COMPARATIVE ANALYSIS OF THE SOUND CONDITIONS AT THE NEONATAL INTENSIVE CARE UNITS OF TWO NORWEGIAN HOSPITALS

ABSTRACT

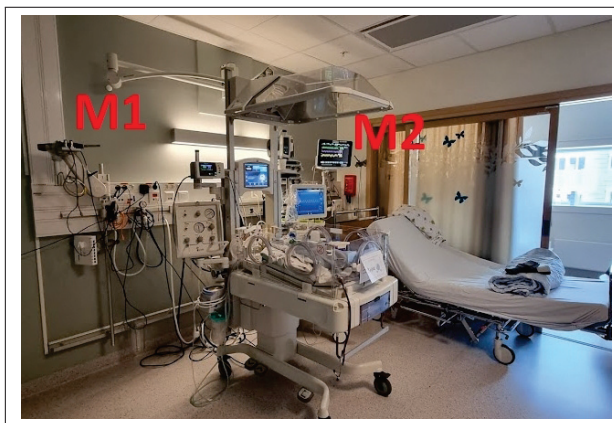
Figure 2. Patient room at location 2 with the measurement positions outside the incubator.

position, two in the room and one inside of an unoccupied and inactive incubator (Fig. 1). At location 2, the sound levels were measured only in the room, at two different locations, also over several days (Fig. 2). Additionally, sound pressure levels inside and outside of an incubator for several operation modes were measured in a quiet room. The microphone inside the incubator was placed at the expected position of the head (Fig. 3). Outside the incubator we used four measurement positions at the four sides. Both locations used the same type of incubator; Giraffe OmniBed Care Station.

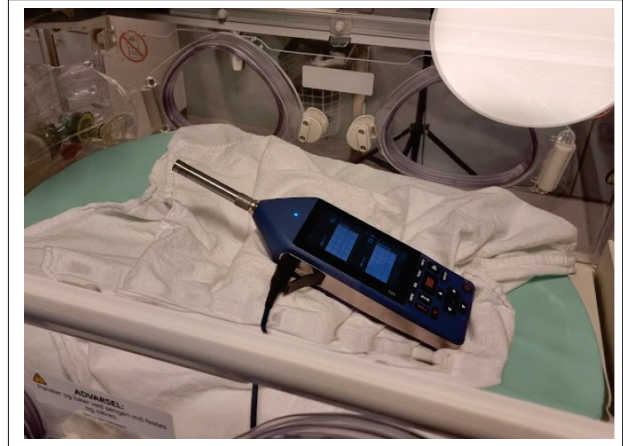
Figure 3. Microphone position inside the incubator.
