# CORRECTION OF A STRONG SEAT-DIP IN THE TEATRO ARGENTINO OF LA PLATA IN ARGENTINA

Gustavo Basso<sup>1\*</sup>

<sup>1</sup> IPEAL, Facultad de Artes, Universidad Nacional de La Plata, Argentina

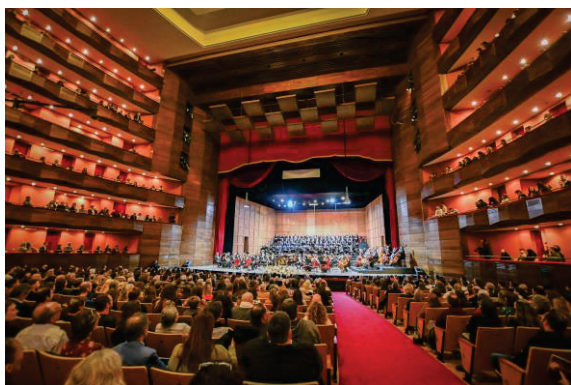
**Figure 4:** The new canopy in position during a concert of Beethoven's *Missa Solemnis*, October 2011.

To fix the acoustical issues detected on the main floor, early lateral reflections within the first 80 ms after the arrival of the direct sound needed to be produced. Consequently, it was decided to place a canopy over the pit, which had to meet the following conditions:

A traditional canopy, made up of large reflective pieces of wood or other material, could not meet all these requirements at the same time. Therefore, it was decided to make a 17.5 x 5 m canopy built of 1.6 x 1.6 m square convex panels to approximately cover the area over the pit, with a panel density of 50% (Figure 4)<sup>2</sup>.

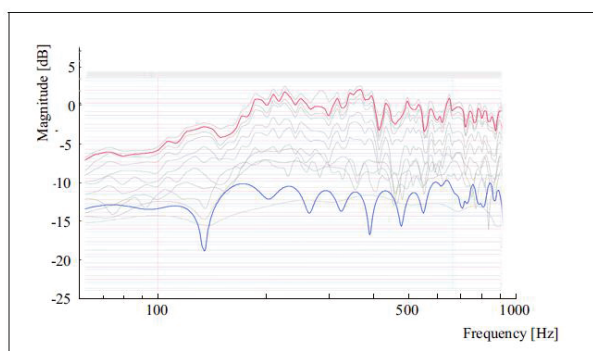
The Sala Ginastera reopened in April 2023 and, both empty and full, no perceptual seat-dip was reported. Figure 6 shows the seat-dip evolution of the impulse response between 20 and 200 ms after the arrival of the direct sound in the same position as in Figure 2.

**Figure 6:** Temporal development of the seat-dip in the centre of the main floor measured in 2019. In blue, impulse response at 20 ms; in red, at 200 ms.

The rapid temporary recovery of the seat-dip aligns well with the opinions of the audience.

To carry out maintenance tasks and solve some problems with the stage machinery, the Sala Ginastera was closed between 2016 and 2023. During this period, which included the Covid-19 pandemic, it was decided for non-acoustic reasons to replace the seats. The author, in charge of the acoustic consultancy, decided to take advantage of this situation to further improve the acoustic quality of the hall in general and the stalls in particular. The new seats are less absorbent and their design, with a higher underpass and a shorter seat, increase the minimum seat-dip frequency to 129 Hz and reduce the differences between the unoccupied seat (seat in an upright position) and occupied seat (seat in a horizontal/down position).
